Consumer Response Group

TECHNICAL SERVICE BULLETIN 10043

MODEL(S): 150GTL, 200GTL

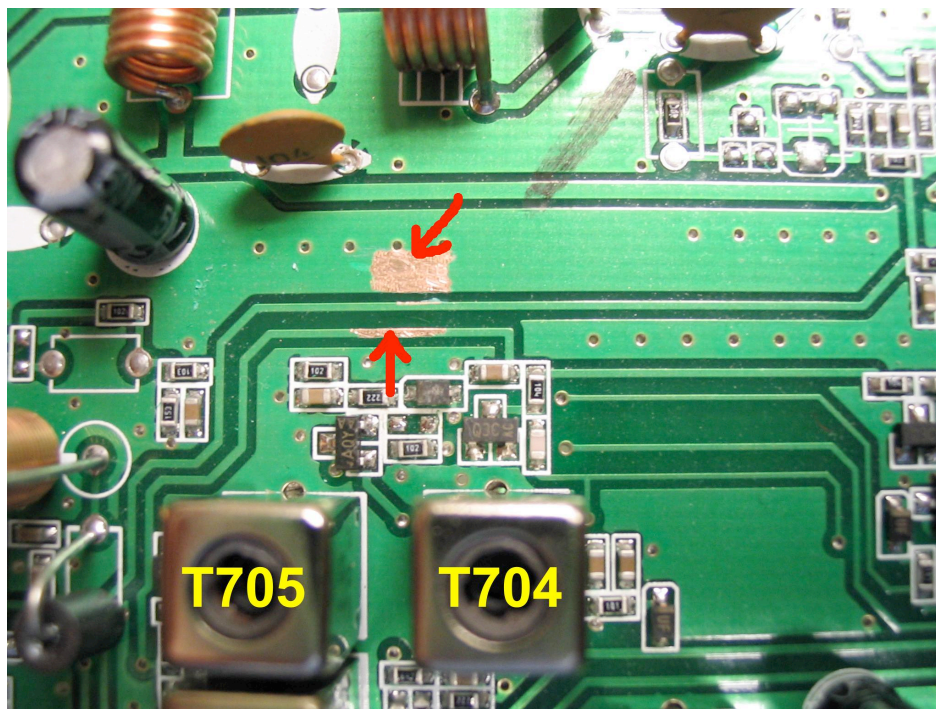
DESCRIPTION: Receiver overloads when receiving a strong signal, resulting in distorted audio. In addition there may be a warble in the modulation when transmitting (which the customer might describe as a popping sound during transmit).

ACTION: RF is bleeding into the receiver front-end. Apply the following fix:

For both the 150GTL and 200GTL, install a 1 μ F electrolytic capacitor across C607. (From C607 to ground)

Scrape to expose the circuit traces as indicated above. The large copper area is ground.
